# WELDING INSPECTION REPORT

**Project Name:** SAS Superstructure **OSM Arrival Time:** 700 **OSM Departure Time:** 1900 **Prime Contractor:** American Bridge/Fluor Enterprises, a JV

**Bridge No:** 34-0006 **Component:** OBG

SHIP # 19, OBG SEGMENT 14W (NWIT # 09821)

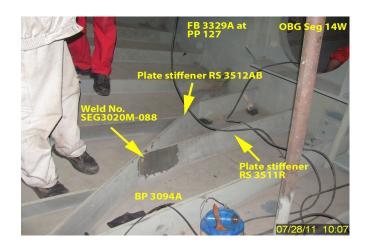
- -One class "A" longitudinal indication measuring approximately 15mm in length.
- -The depth of the indication is 17mm from face A.
- -The db rating is +2.
- -The material thickness is 20mm.
- -The weld is identified as: SEG3020M-088.
- -The Weld is a Complete Joint Penetration (CJP), Tee-joint, joining the plate stiffener RS3511R to plate stiffener RS3512AB on Bottom Panel (BP) 3094A near Panel point (PP) 127 (E).
- -The "Y" location of the indication is 25mm from free end of weld.
- -The indication is clearly marked on the component.
- -The member is located in ship Zhenhua # 19.

The Notice of Witness Inspection Number (NWIT) is 09821. The indication is located inside the area that has been previously tested and accepted by ZPMC Quality Control (QC) personnel. As per the contract documents, ZPMC's QC personnel are required to perform 100% UT inspection of these welds.

Incident Report (IR) was generated regarding this issue on this date. See attached photograph for more details.
